Report of Sampling and Analysis Results

Burlington Army Housing Units
Burlington, Massachusetts

June 1990

CETHA-BC-CR-90085

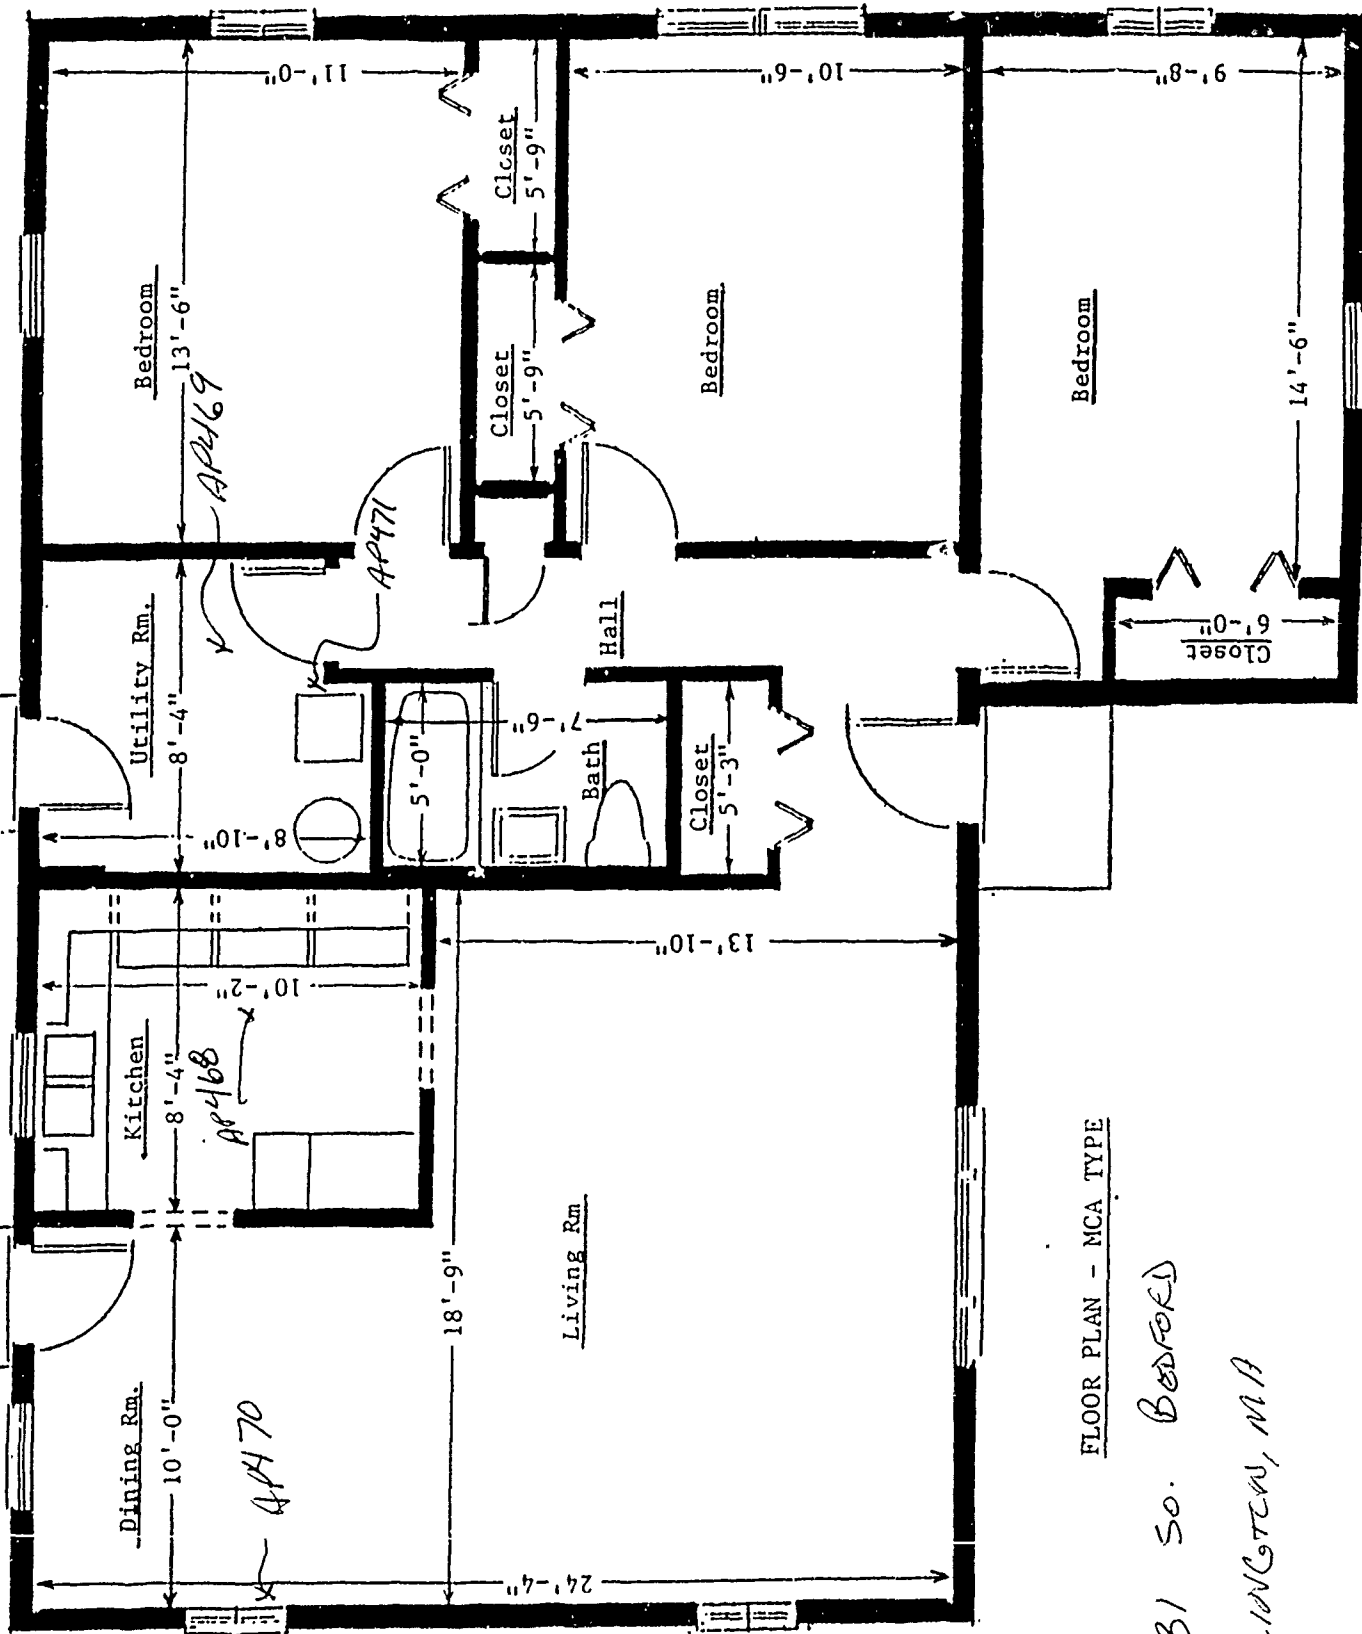
131 So. BEDFORD
BURLINGTON, MA

NOTE NO.	NOTES/REMARKS/COMMENTS/DETAILS/OTHER MATERIALS, QUANTITY, ETC.
01	12x12 brown floor tile in kitchen floor.
02	9x9 Grey floor tile, patch in utility room
03	9x9 white floor tile over old floor vents.
04	9x9 Grey (dark) in all rms except except kitchen.

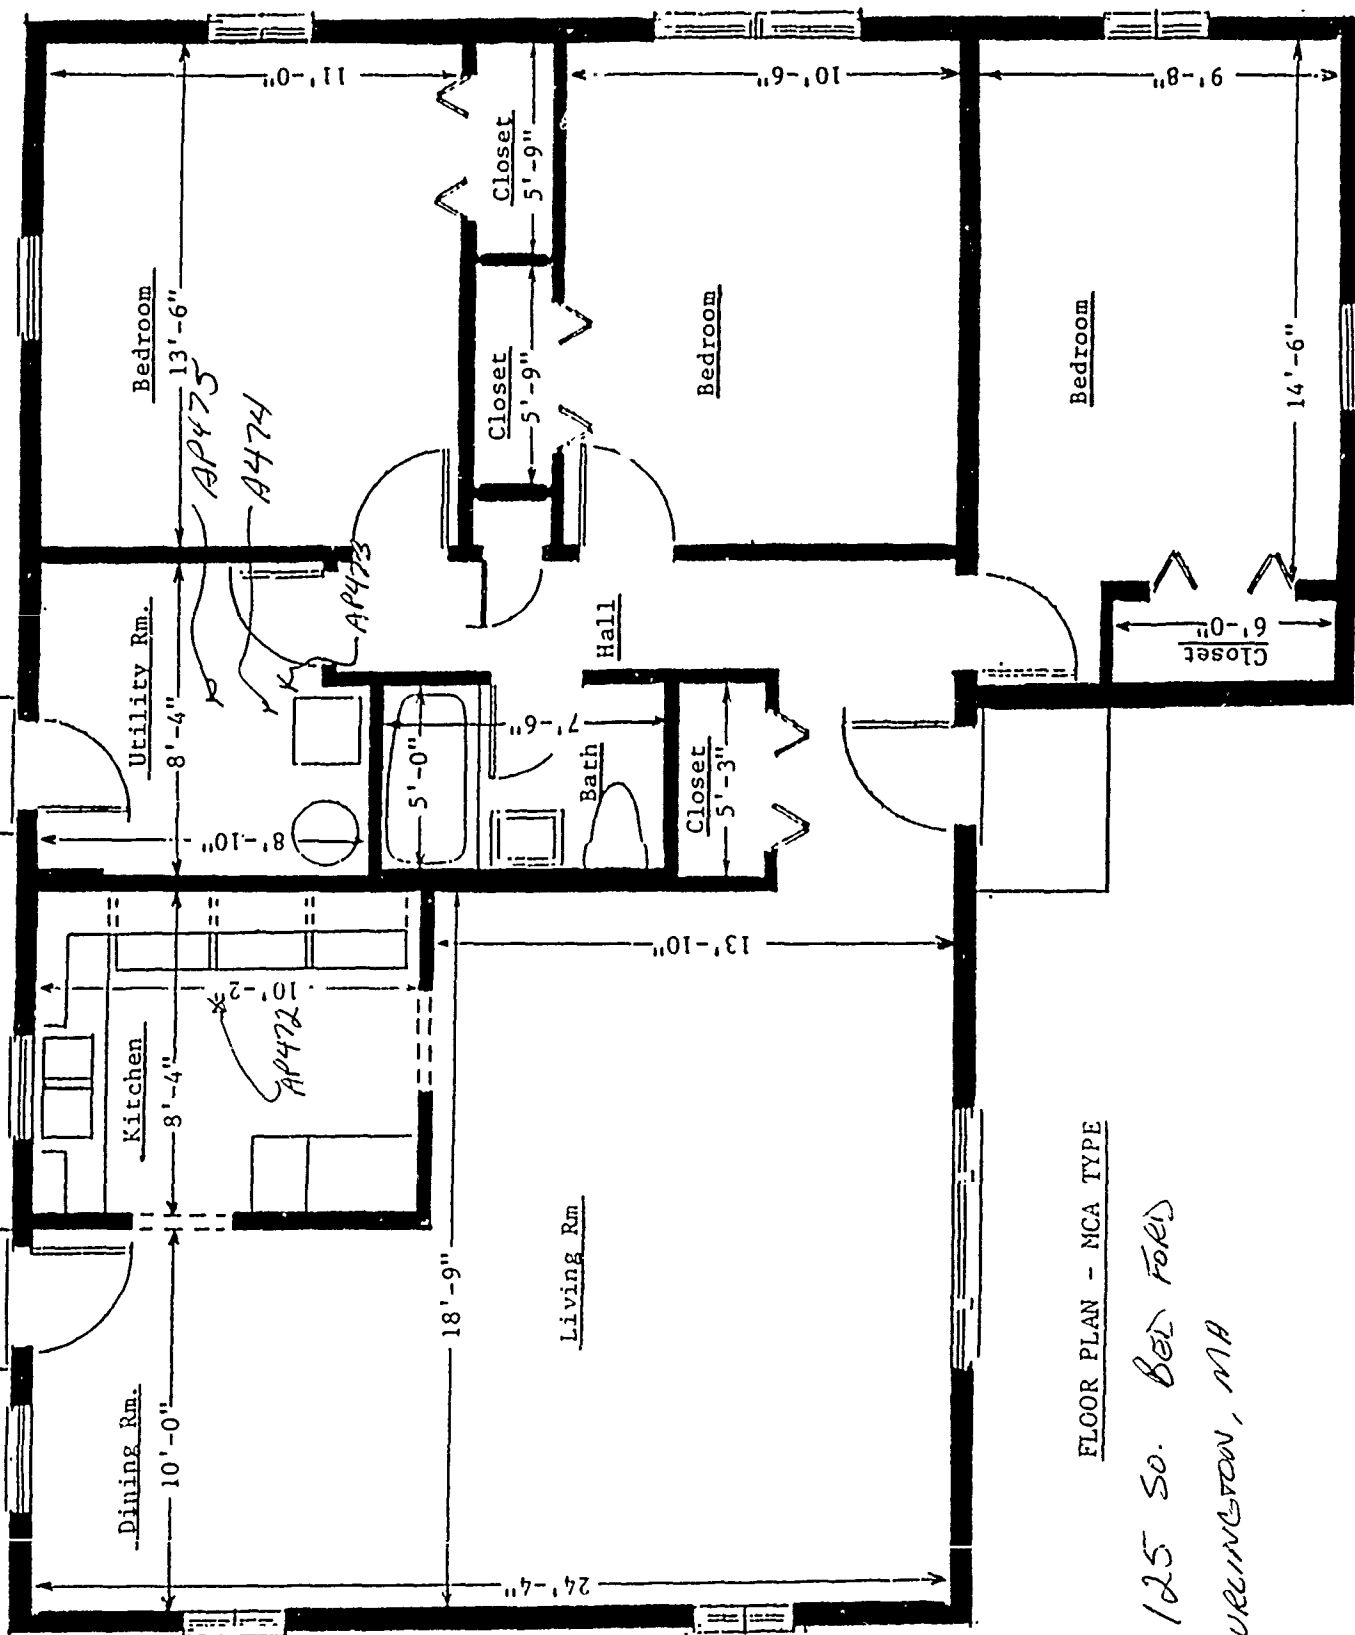
125 So. Bedford
Burlington, MA

NOTE NO.	NOTES/REMARKS/COMMENTS/DETAILS/OTHER MATERIALS, QUANTITY, ETC.
<u>01</u>	<u>12x12 brown floor tile in kitchen only</u>
<u>02</u>	<u>9x9 dark gray floor tile in all rooms except kitchen.</u>
<u>03</u>	<u>9x9 white floor tile over old floor vents.</u>
<u>04</u>	<u>9x9 black floor tile used to patch areas in home.</u>
